# STILES POND DAM

VT 00054

## PHASE I INSPECTION REPORT NATIONAL DAM INSPECTION PROGRAM

OCTOBER 1979

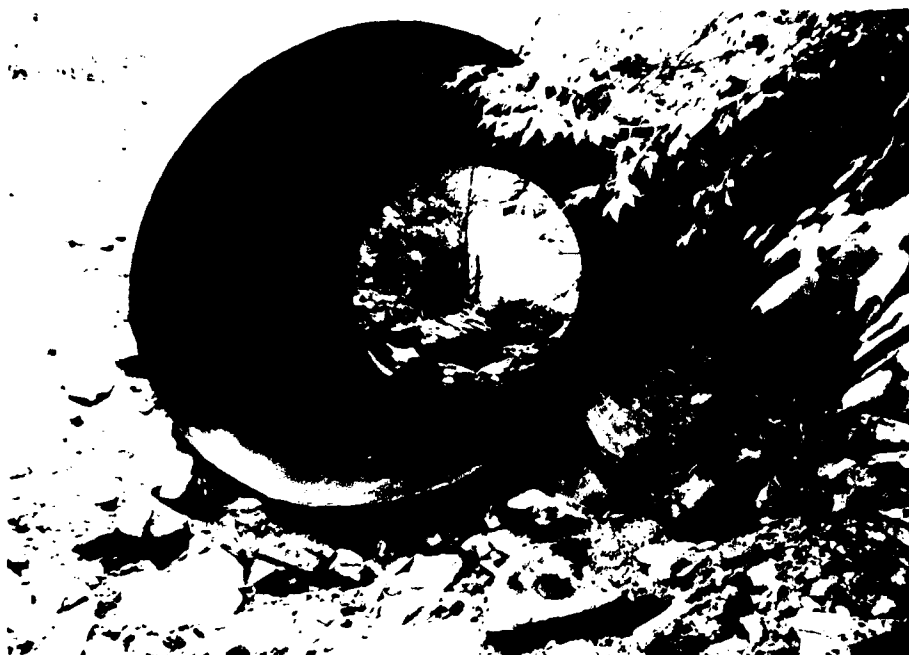
The roadway bridge over the discharge channel in Photo No. 23 consists of a steel plate pipe culvert, 8 feet in diameter. The top of the gravel surface roadway is approximately 2 feet above the top of the pipe. Both the roadway and the steel pipe appeared to be in fair condition.

PHOTO NO. 23 - View of downstream end of culvert under roadway.
